# Materials and details

# 3 **Elements** damaging or threatening to the character of the conservation area

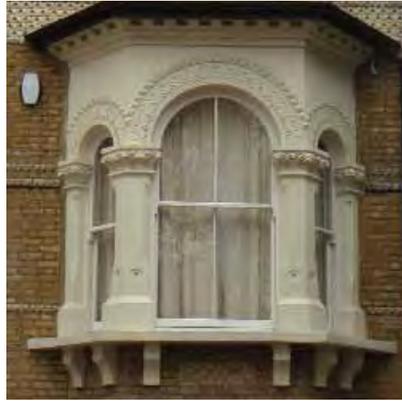
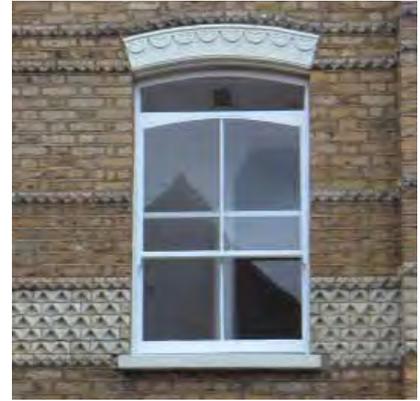
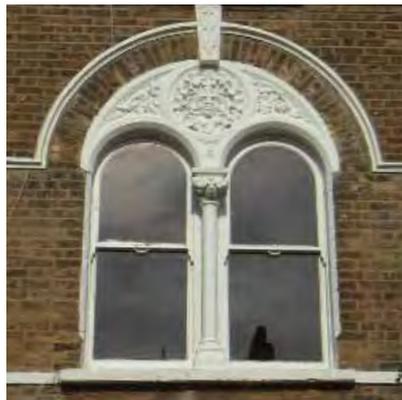
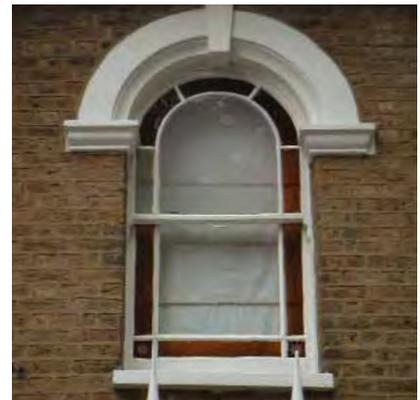
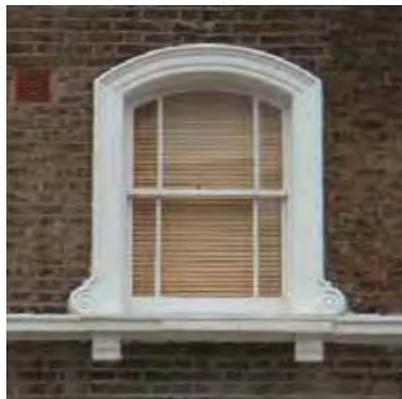
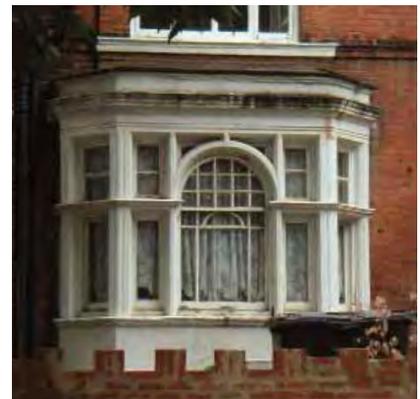
## Windows

Windows are key features in all the houses in the conservation area. The location of the windows, their proportions, the number of glazing bars, the use of coloured glass, or the presence of old glass and the decorative treatment around the windows, all give each house its special character. The diversity of window types across the conservation area makes a strong contribution to the area and therefore they should not be altered.

**Upvc and aluminium windows** cannot reproduce the detail and dimensions of painted timber. Mock glazing bars in particular cannot be reproduced satisfactorily and are often unattractively sandwiched between panes. Double glazing reflects the light in a different way to old glass which has reams or appears wobbly, which adds to the charm of the area. Of all the sash windows in the conservation area, 13% have been unsuitably replaced. In Cranfield Road 35% of windows have been replaced, in Vulcan Terrace 37% have been changed and in Eastern Road 70% of original windows have been removed which has drastically devalued the historic appearance of this street.

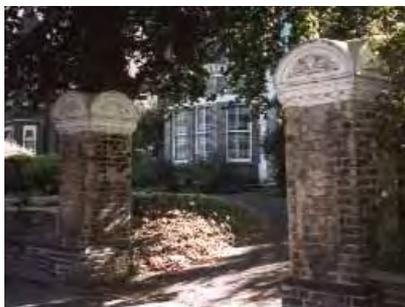
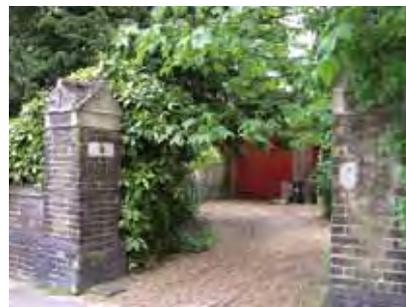
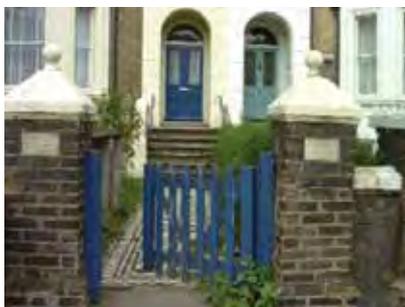
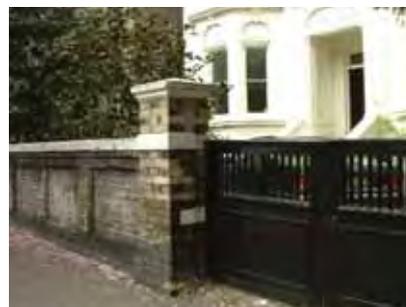
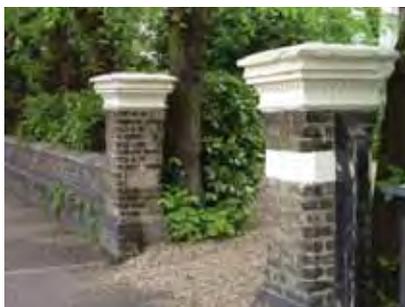
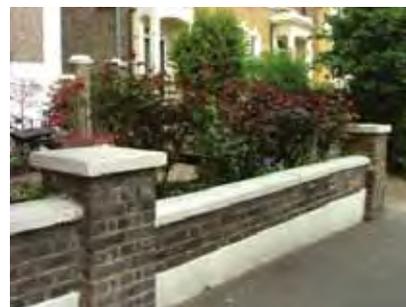
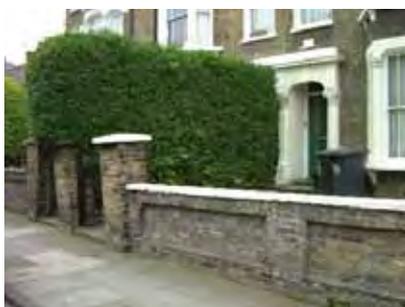
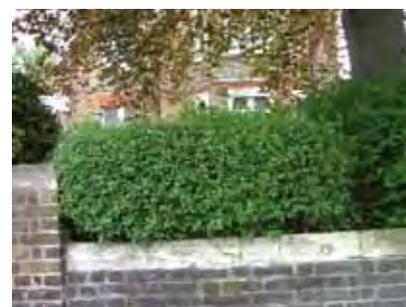
## Boundary treatment

Relatively few original boundary walls and railings remain, but those that can be seen are often sturdily built with materials and details to echo those of the properties they enclose. Some large decorative caps exist, often with the name of the house carved in the stone. Where sympathetic boundary treatments have been reinstated the setting of the house and consequently the appearance of the conservation area is greatly improved.

**Boundary walls:** Many of these have been removed, but those that remain are of great character in themselves and worthy of retention. Replacement walls can appear small and insubstantial and often not befitting the grandeur of the buildings behind them. Of front walls in the conservation area 55% have been rebuilt to modern designs. In seven streets in the conservation area more than 75% of original walls have been removed.

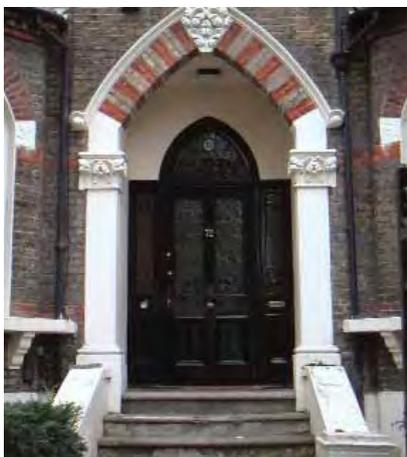
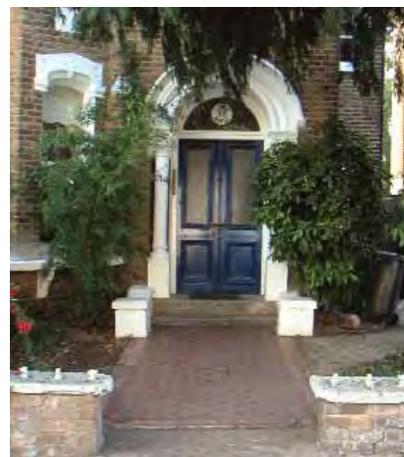
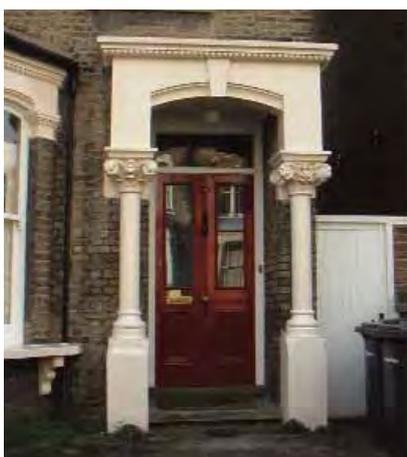
## Doors

Many doors in the conservation area are richly detailed. They are heavier and have deeper mouldings than doors generally available today. Many have leaded lights and coloured glass or even their original etched glass. Further attention is drawn to entrance doors by their elaborately detailed surrounds and porches. Doors add to the richness of the conservation area.

**Modern doors** are either too fussy or completely lacking in detail. Inappropriate materials have a different appearance and weather differently. Many door frames incorporate a fanlight to light the hall and it is unnecessary and unattractive to install doors with modern 'fanlights' designed in them. In the conservation area 20% of all front doors have been unsuitably replaced.

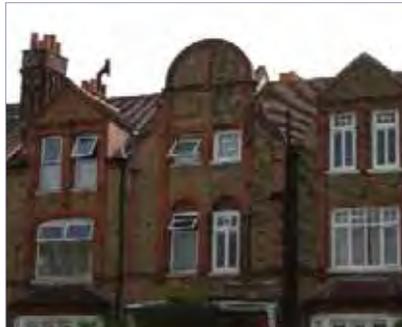
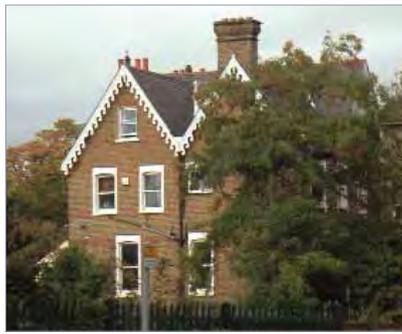
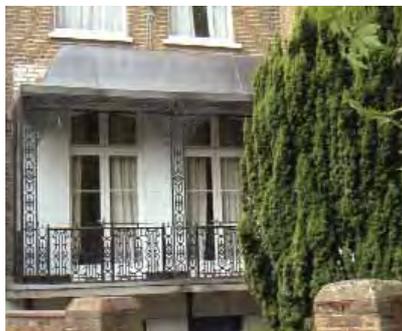
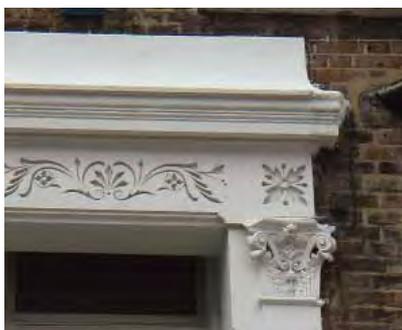
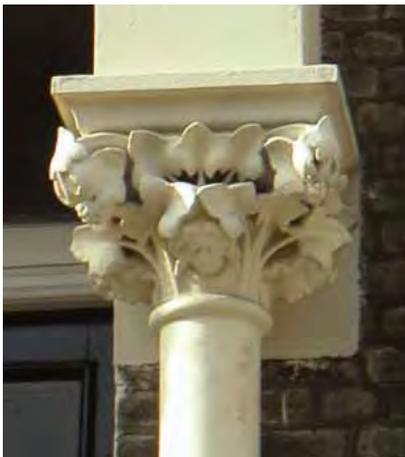
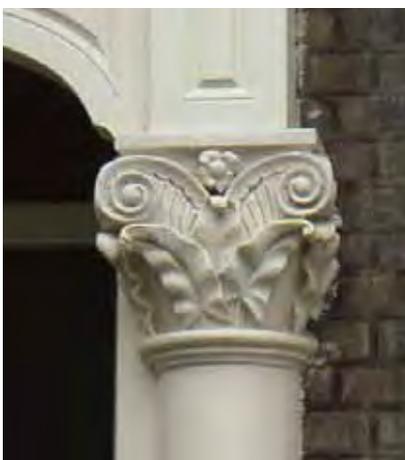
## Architectural detail

Brockley is rich in architectural detail, which was included in house designs to increase their quality and reflect the status of their owners. Even the seemingly plain terraces have some ornamentation such as bracketed eaves, imitation stone quoins and stucco cornices over doorways and windows. Such detail adds luxury and quality to the area.

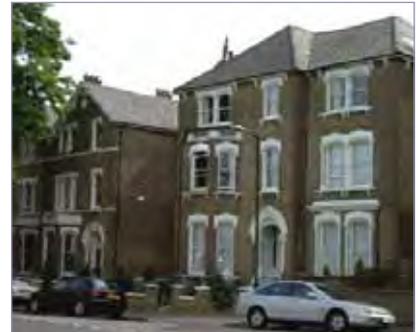
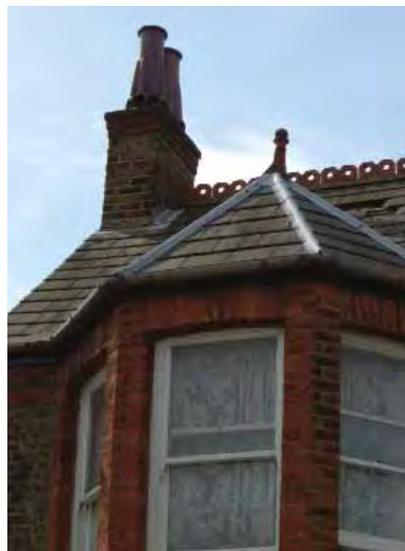
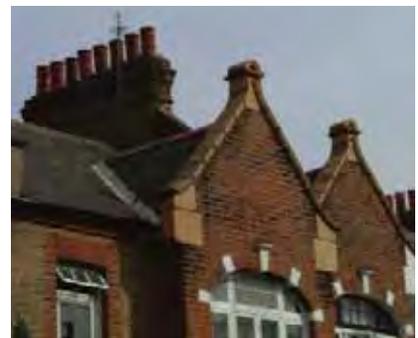
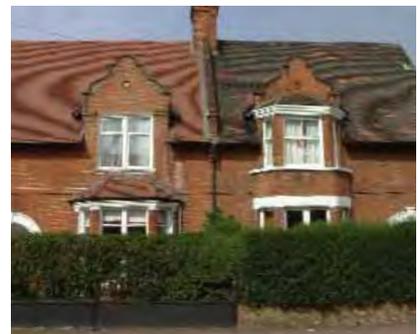
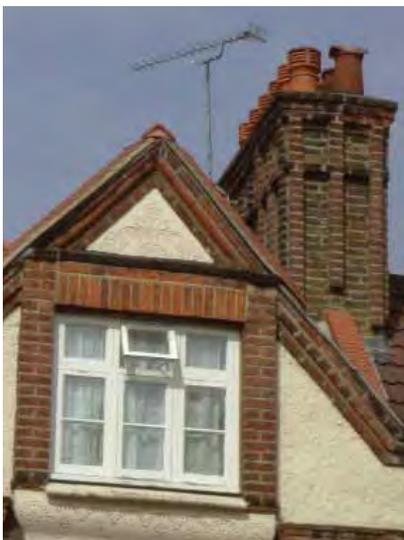
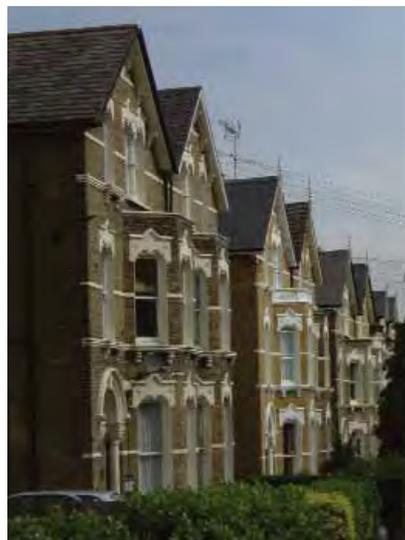
## Roofs and chimneys

Houses in the conservation area are finished with slate or clay tile roofs topped with substantial chimney stacks and terracotta pots. Dormers only appear on rear roof slopes as seen above and roof lights are not a historic feature of front roof slopes.

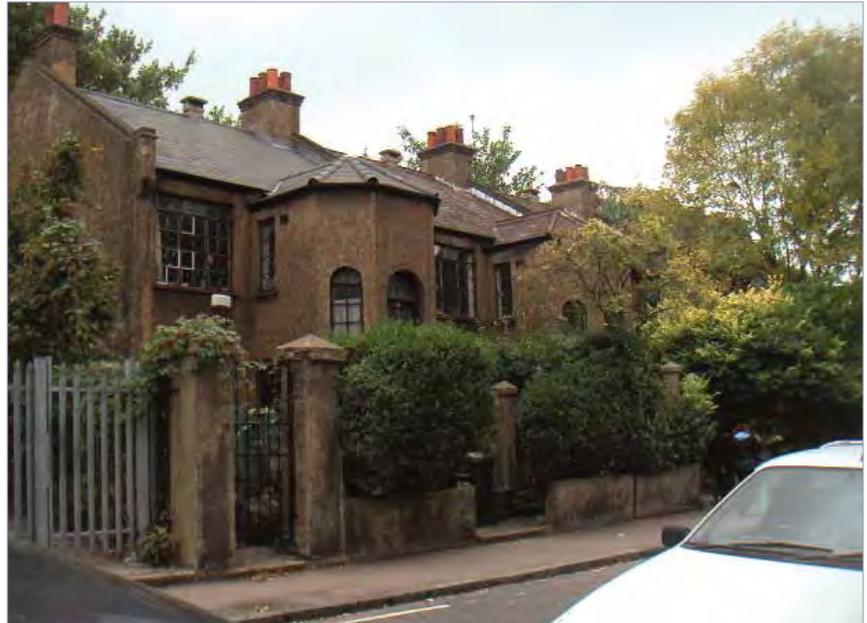
Nos 74–83 Rokeby Road and Brockley Gardens have a neutral effect as their scale, materials and design make no attempt to compete with the historic architecture, but neither are they buildings of sufficiently high-quality design to make a positive contribution.

74-83 Rokeby Road. Low key housing which does not damage the character of the conservation area

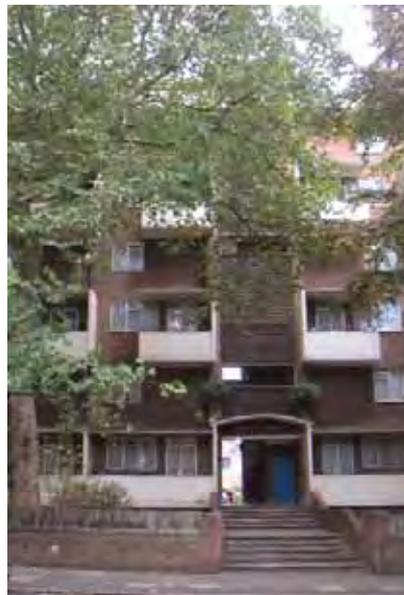
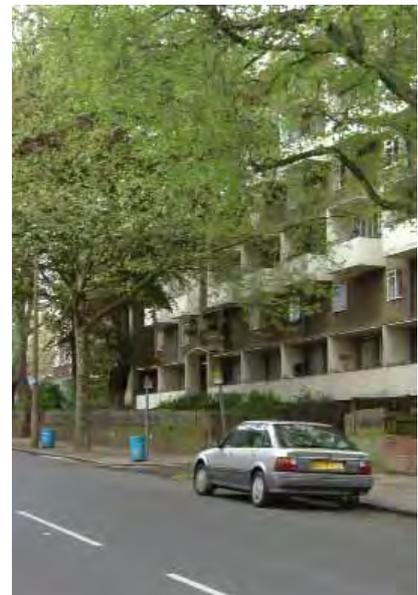
Jasmine House on Wickham Road is a similar case which displays restrained 1950s style in its simplicity with simple balconies and elegant Crittal windows for decoration. Although of six storeys, the building is less visually intrusive as it sits lower on the slope and it follows the building line of the Victorian houses with an expanse of lawn and trees softening its impact to the front.

Jasmine House follows the building line of Wickham Road and its impact is softened by trees

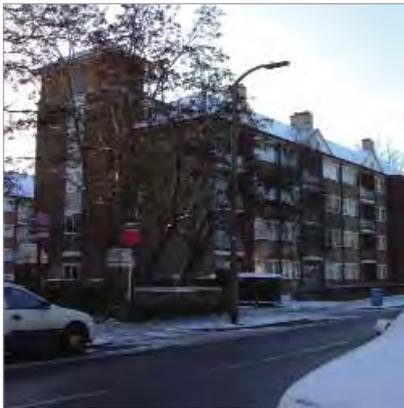
Post-War infill development: Large blocks of flats such as Colin Blanchard House and St Peter's Court in Wickham Road detract from the historic character of the conservation area as their design bears no relation to the surrounding architecture. However, the softening effect of street trees and the conformity

of their building lines and front gardens does mitigate their impact to a certain extent. Two buildings on Coulgate Street also have no historical or design relationship to the area.

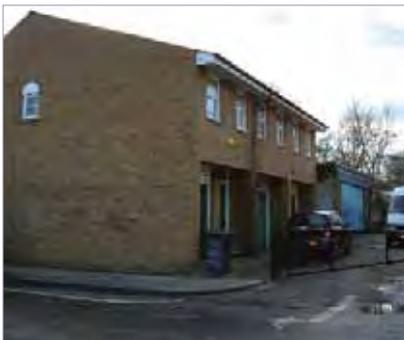
1-3 Wickham Mews

Piecemeal development has taken place mainly at junctions where the mews meet the street. Due to the constraints of these corner junctions, it is not possible for development to conform to the character, style and street pattern of the conservation area and this has resulted in poor quality buildings which detract from the character of the conservation area. The mews have been under increasing pressure for development for years.

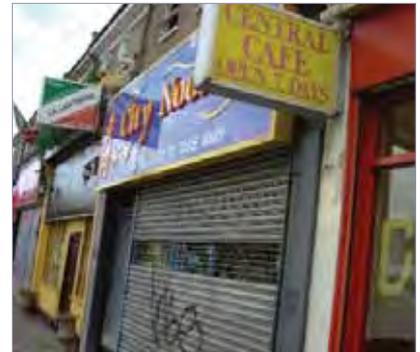
**Unsympathetic shopfronts:** Shopfronts in Upper Brockley Road, Brockley Road, Brockley Cross and Lewisham Way have had their historic shop fronts removed over the years and replaced by unsympathetic shop fronts, security shutters and oversized fascias in unsuitable materials such as aluminium and upvc. In addition, this has been done in a piecemeal fashion and without regard to the overall cohesion of the streetscape, giving rise to an unattractive and muddled appearance.

Non-traditional shopfronts

- reinstatement of sash windows where lost
- reinstatement of original style doors, such as the Victorian four-panelled door, where lost, or the removal of porch doors
- removal of render or pebbledash where not part of the original design
- reinstatement of terracotta chimney pots where missing
- reinstatement of slate or good quality artificial slate to roofs
- repair or reinstatement of architectural detail where lost
- front garden improvements such as the reinstatement of a stock-brick walls with stone copings; planting of shrubs, lawn and hedging to hide wheelie bins, and the repair or reinstatement of York stone or coloured tile paths
- resiting of satellite dishes to inconspicuous locations such as the rear garden
- reinstatement of traditional shopfronts and removal of internally illuminated signs.

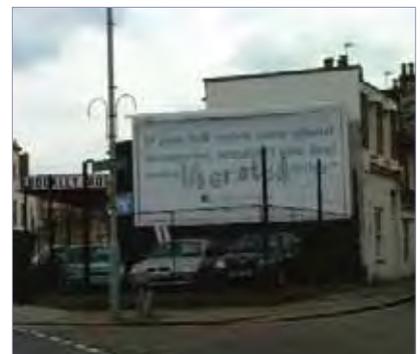
**Advertisement hoardings:** Such advertisements around Brockley Cross are large and unsightly.

Obtrusive advertising

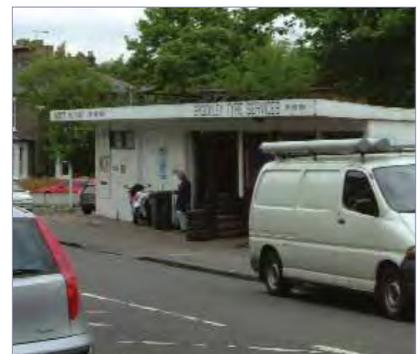
**Unsuitable land uses:** A number of commercial garages exist, such as those in Upper Brockley Road and Brockley Road, in addition to the residential garages in the mews, which detract from the area's character by their untidy, poor quality buildings as well as their noise and dirt creation. Lewisham College's car park on Lewisham Way also does not contribute to the area's charm.

Poor quality garage building

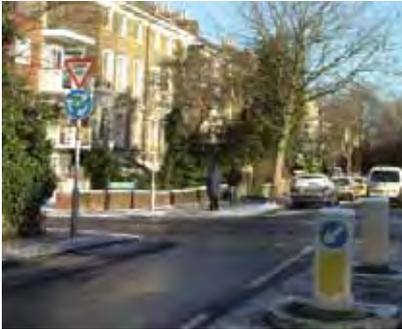
Brightly coloured plastic bollards and modern signage

**Road signs and street furniture** are intrusive because of their materials, colour, design and collective impact. Road signs are made of reflective materials and their impact is often worsened when they are grouped together giving a cluttered appearance.

The council aims to improve the public realm where this is in our control. The Transport Division is revising and reissuing a Streetscape Design Guide which will be a guide to appropriate alterations in conservation areas, including the use of appropriate materials, minimisation of clutter and black-painted street furniture.

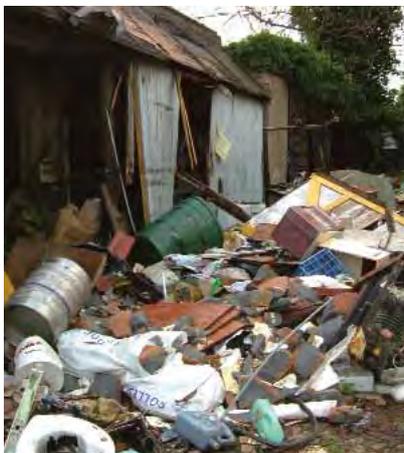
Fly tipping

**Fly-tipping and graffiti** occurs extensively in some mews and is aggravated by the narrowness and car-parking which impedes access to refuse-collecting vehicles. Graffiti can be seen on most timber gates leading into gardens.

The Environment Division deals with issues such as fly-tipping, graffiti and street cleansing and has set up a number of ways for these to be reported. Report problems using our Visible Difference website ([www.lewisham-visibledifference.org.uk](http://www.lewisham-visibledifference.org.uk)), by texting a photo (details on [www.lovelewisham.org](http://www.lovelewisham.org)) or by calling Envirocall (**020 8314 7171**).

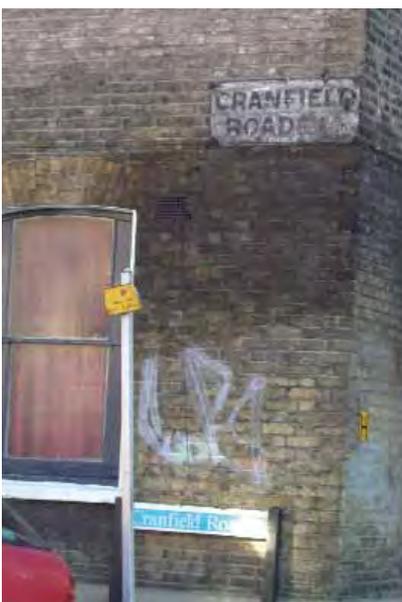
The Council's corporate style has been imposed on the area without regard to what might have existed historically. Earlier street names can still be seen painted onto house walls, but, today's street signs are in 'Lewisham' blue often supported by black recycled plastic posts. The design is poor and the appearance does not fit in with the character of the area. Blue plastic litter bins also look out of character.

New and old street signs

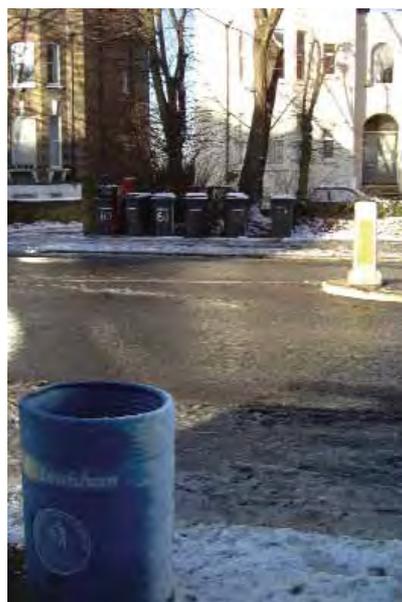
**Wheelie bins** are unsightly when left untidily in front gardens and on the street and are unnecessarily numerous due to every flat having its own bin.

Wheelie bins and a blue plastic litter bin

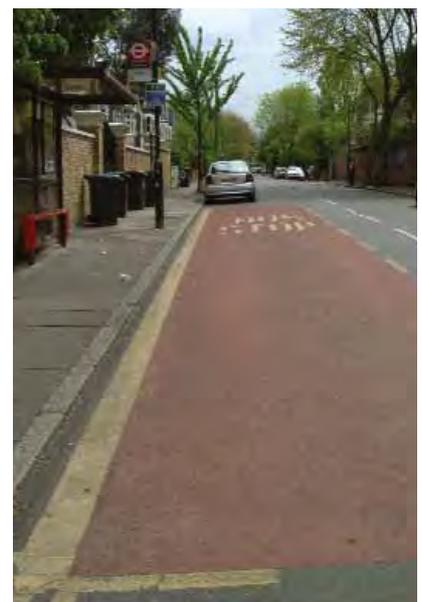
**Modern bus stops** with their shelters, red plastic seating and in particular, areas of the road painted red are a startling intrusion on the historic character.

Bus stop with painted section of road

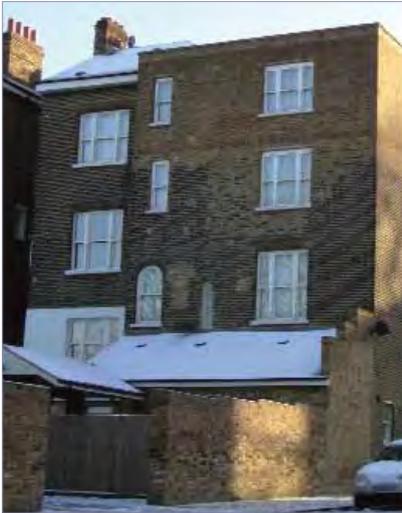
A rear extension which is very large and changes the shape of the house

**Rear extensions** are often clearly visible from the street due to the street layout. This means that poorly designed extensions often interrupt the clean lines of the buildings and spoil their regular appearance. Corner houses are particularly sensitive locations due to their prominent visibility and therefore require particularly well-designed additions.

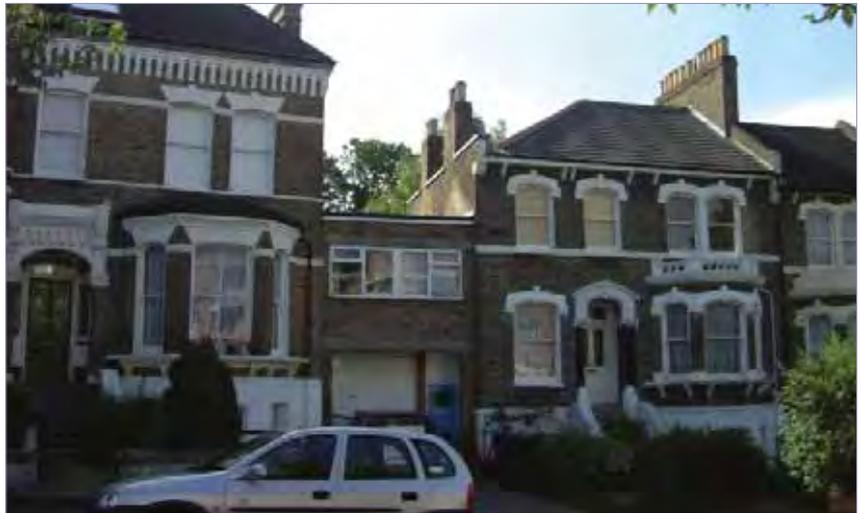
Two examples of side extensions which both close the gap between houses and alter the balance of the streetscape

**Side extensions:** Where buildings have been joined or the gap between buildings has been closed by side extensions, the character of that part of the conservation area is damaged. Such extensions block views, may result in the loss of trees and unbalance the historic street layout.

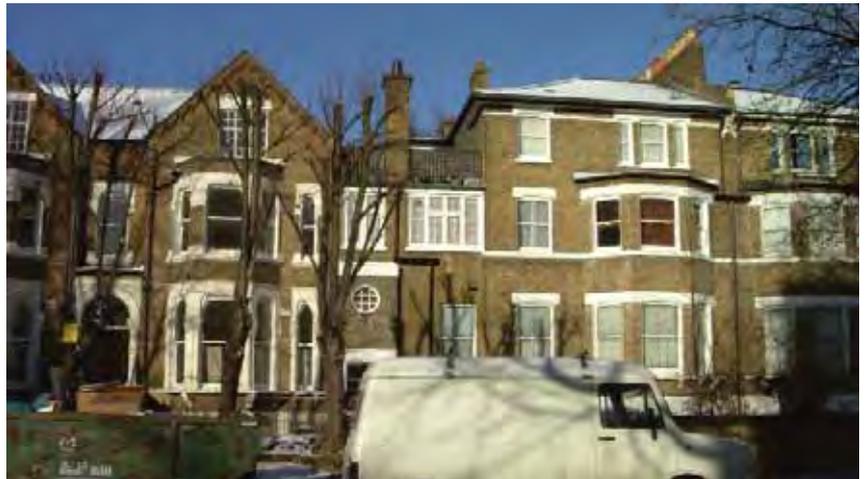
**Roof extensions** can easily be seen due to their height and the layout of the streets. Full width roof extensions and bulky dormers severely detract from the character of the area.

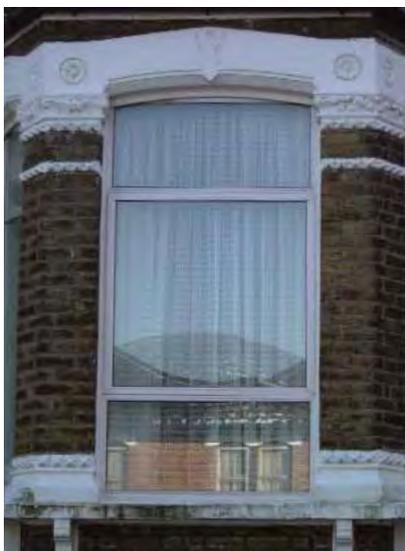
This aluminium window is unsuitable both in its materials and its design

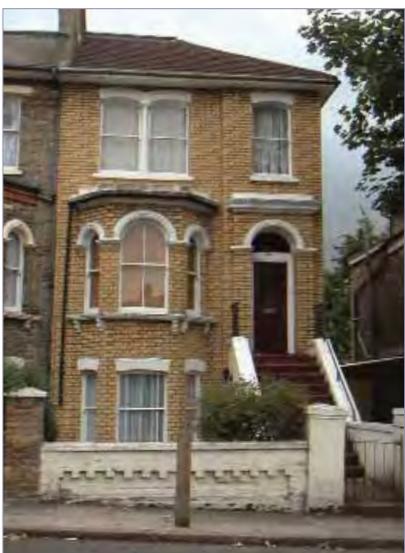
A badly repointed house where the eye is drawn to the dark ribbon pointing rather than the mellow stock brick

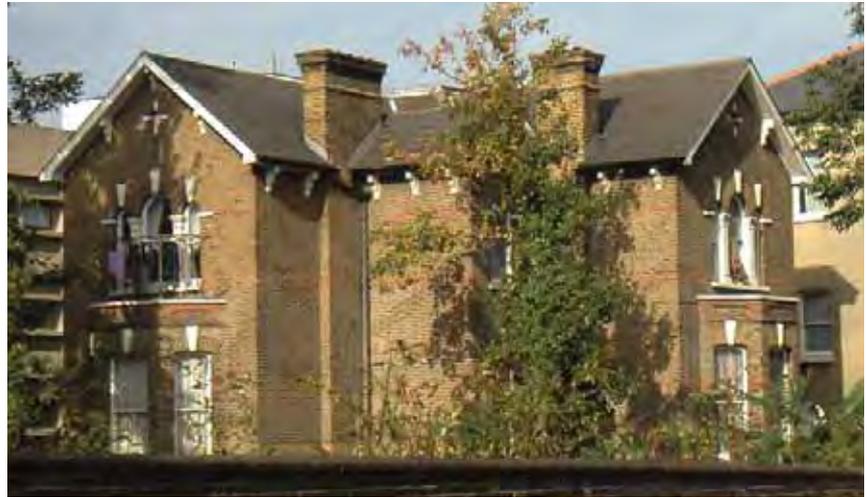
**Shortened chimneys** alter the balance of the building and the regularity in the streetscape. Often details such as decorative brick courses are also lost. Modern chimney pots and flues look out of place and give a cluttered appearance when several unsympathetic types are used together.

The lack of chimney pots make this house look incomplete

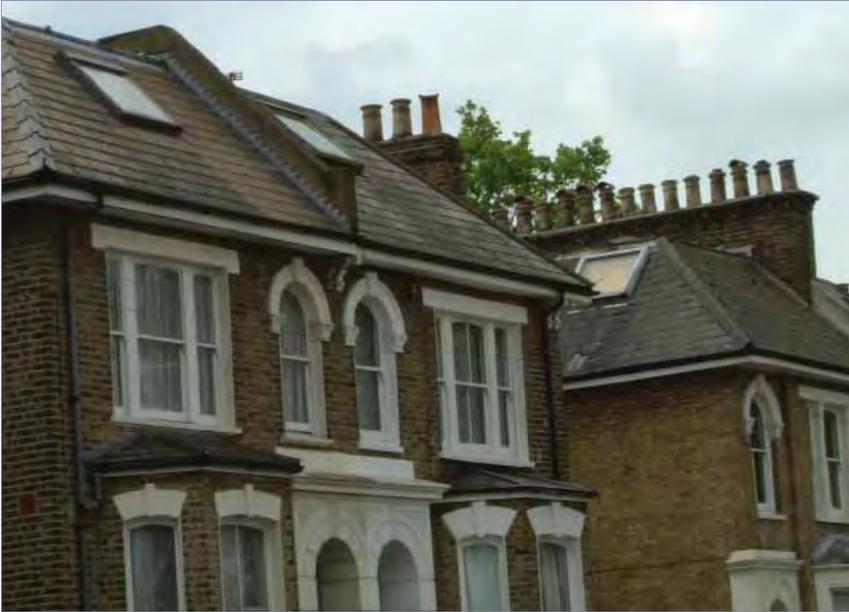
Intrusive rooflights of a modern design fitted proud of the roofslope

**Rooflights** add visual clutter to plain roofslopes which were not historically pierced with openings. They introduce unsympathetic modern materials such as coated aluminium and double glazing into traditional settings. The design of rooflights is often unsympathetic as they stand proud of the roofslope and have wide, bulky frames. When open their appearance is even more intrusive. Of houses in the conservation area, 9% have one or more rooflights on their front roofslopes. Hilly Fields Crescent and Crescent Way have the highest percentages (32% and 33%) and in Geoffrey Road, Cranfield Road and Montague Avenue, between 19–23% of houses have rooflights.

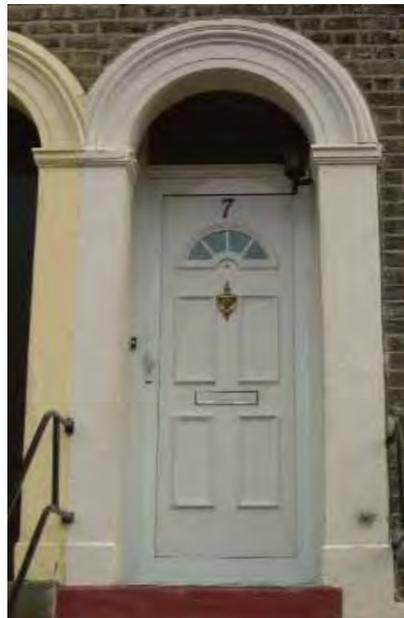
A UPVC door

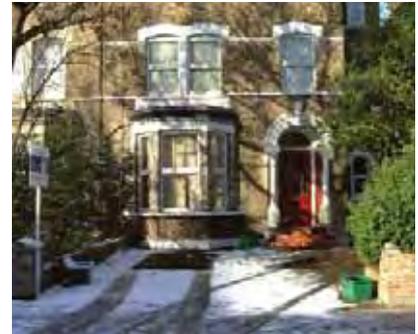
**Hard-standings** are fortunately not profuse in the conservation area, but where they occur they often cause the loss of trees, shrubs and other vegetation as well as the removal of the traditional wall and garden path and generally cause an unattractive 'concrete jungle' effect. In the conservation area 15% of houses have hard-standings in their front gardens. Only 11% of houses across the whole conservation area still have their original stone flag paths or later tiled paths. However, in Tressillian Crescent 40% of houses have retained their early paths.

Hardstanding and UPVC windows

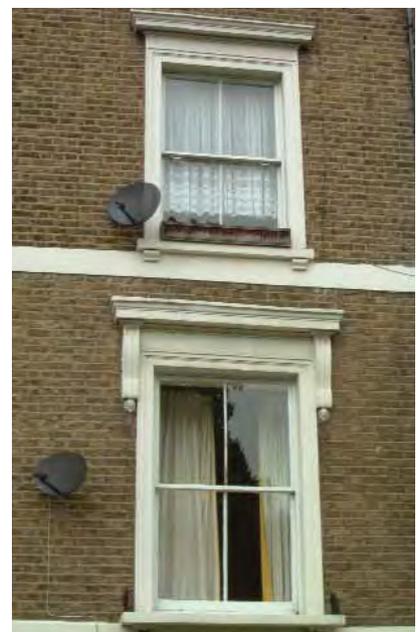
**Satellite dishes:** A proliferation of these causes visual clutter. Across the conservation area 14% of houses have one or more satellite dishes on their front elevations and roofs. In Cranfield Road and Glensdale Road 28% and 27% of houses have satellite dishes on visible elevations.

Poorly sited satellite dishes

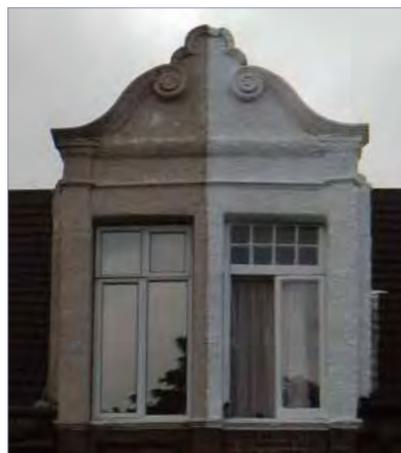
**Painting:** Painting whole elevations also changes the appearance of a building and is particularly visually disruptive when one house in a terrace is painted. Stucco and terracotta detailing was not always meant to be painted and can decay under impermeable paint layers.

A sadly altered and painted gable
